Home Performance Partners Recommendations

Client: Town of Berlin, Ray Tanguay
108 Shed Road
Berlin, VT 05602

Summary: Home Performance Partners was called on to do an energy audit at the Town of Berlin's Town office. One section of the building was having significant ice damming problems during the winter. A blower door test was done to determine exactly how much air leakage the building had and where it was coming from. Both attics were inspected and evaluated. The oil boiler was also tested for efficiency and safety. The findings and recommendations are as follows.

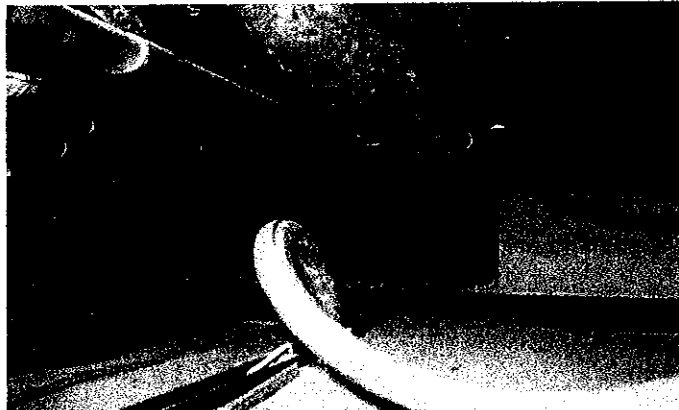
- The building was found to be quite drafty at 5,300 CFM50. The majority of the air leakage was coming from the attic of the original building. This part of the building has a drop or hung ceiling and fiberglass insulation stapled between the bottom cord of the roof trusses. There is no "air barrier" in this assembly, such as a sheetrock ceiling to stop air leakage from the office space to the attic. This lack of an air barrier is what is causing the ice melting on the roof, as well as the high heating bills.

There is no air barrier here to stop air leakage.

- The original building needs an air barrier to stop air leakage. The most effective and efficient way to get this air barrier and effective insulation is to apply spray foam to the bottom of the roof deck. This could be applied from the attic onto the plywood roof sheathing, and the gable end walls in the attic. There would be very little disruption to the office below. Five inches should be applied on the roof and three inches on the walls. This must be applied continuous down to the concrete block walls, to stop the air leakage at this exterior wall to roof junction. Insulating the roof in this manner will give a superior

air seal and a true insulation R value of 35. Because of all the pipes and wires run above the hung ceiling, and because of the poor existing fiberglass insulation, installing a sheetrock ceiling above this drop ceiling would be impractical, not to mention a very disruptive job. The results would also be far inferior to the foam insulation.

There is approximately 1776 sf. of roof deck to insulate, and 288 sf. of gable end wall to insulate. NOTE: This foam may need to be coated with a fire retardant to meet certain codes.
